FABRICATION OF LIGHTWEIGHT TURBINE
COMPONENTS USING ELECTRON - BEAM WELDING
FOR THE ATTACHMENT OF SHEET METAL BLADES
TO DISCS AND SHROUDS

TECHNOLOGY REPORT

CONTRACT NAS 3-2555

AEROJET-GENERAL CORPORATION
LIQUID ROCKET OPERATIONS
SACRAMENTO, CALIFORNIA

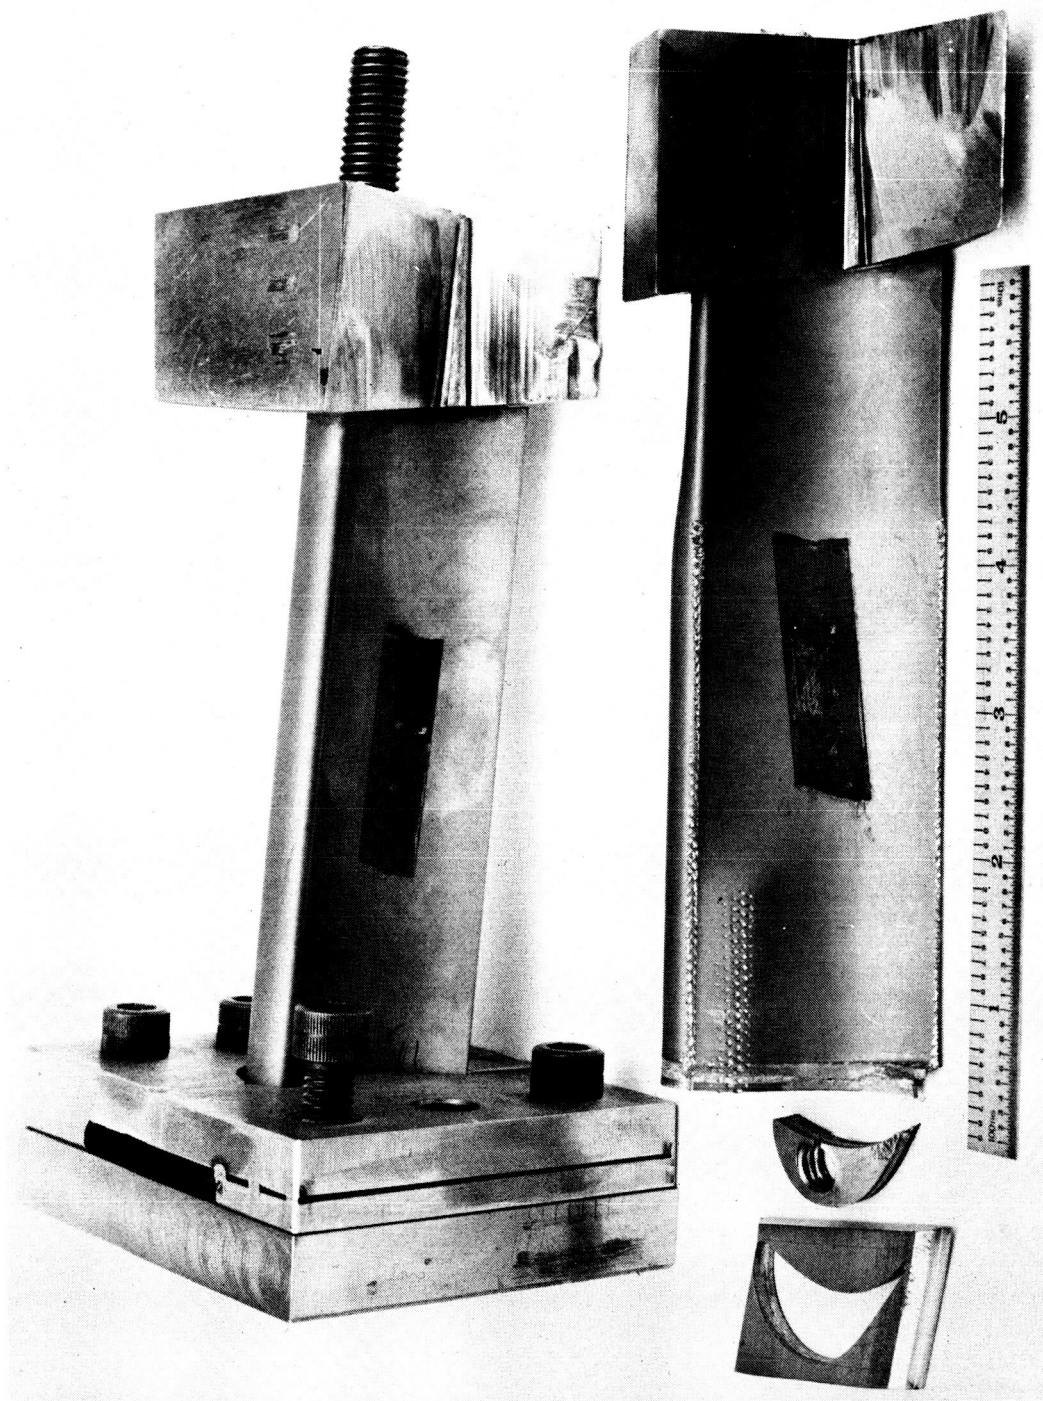
Figure 27

Test Fixtures for Tensile Testing of Blade Samples

The objective of testing the heat-treated blade segment shown in Figure No. 27 was to establish the mechanical strength of the weld joint, and thereby to obtain an estimate of the reduction in joint efficiency attributable to porosity and microfissuring.

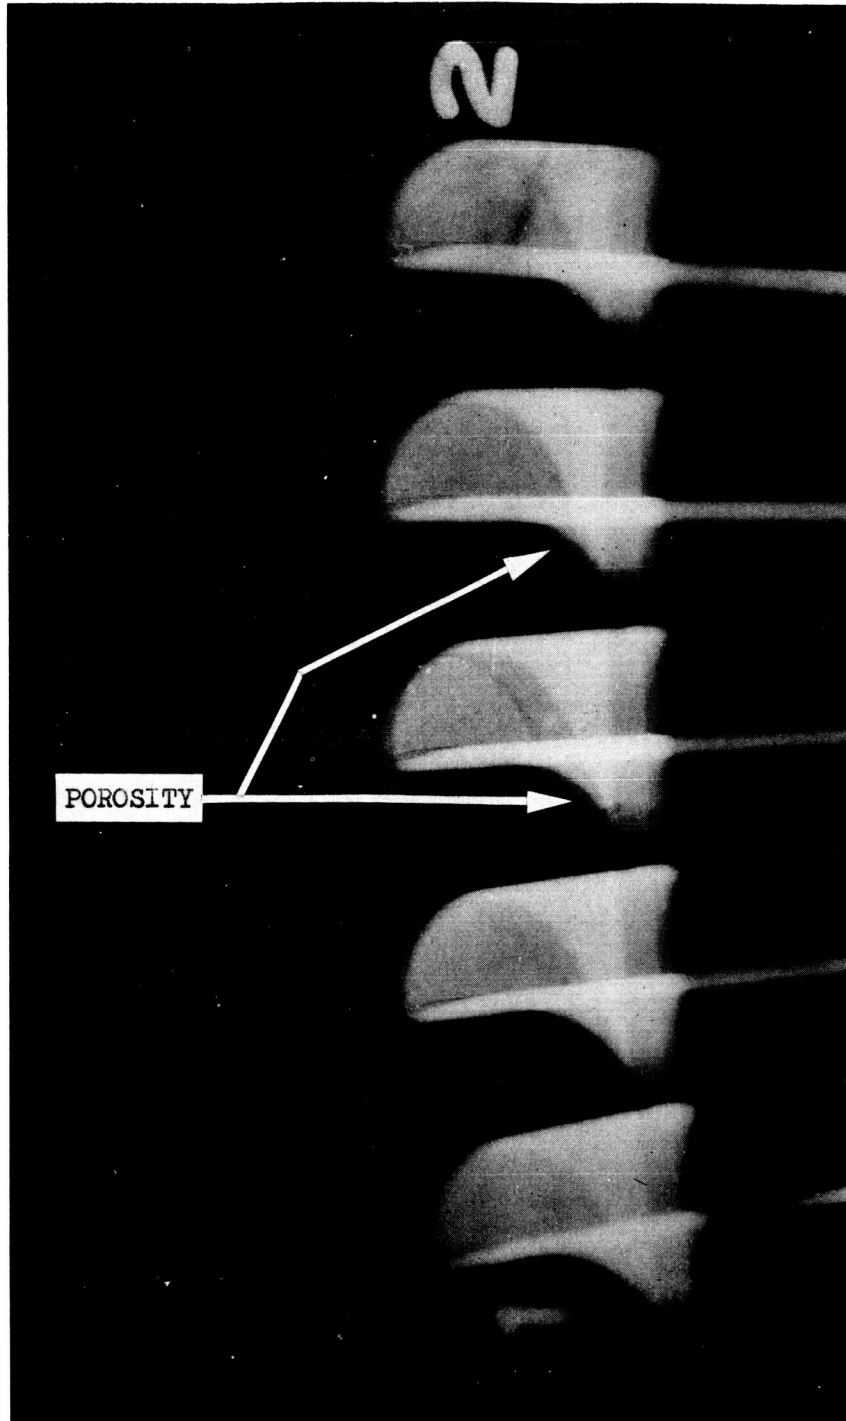
Figure 28

Photograph of the X-ray Film Showing the Porosity Condition
Which Existed in the Shroud-to-Blade Weld of the First
Second-Stage Dummy

The radiographic evaluation of the dummy assembly gave a good indication of the amount of porosity present in the weld. However, a superposition effect was noted on the radiograph of the outer shroud weld of the first dummy. In this radiograph, which was taken parallel to the weld, a dark indication approximately two-inches long and as wide as the weld was observed. In an effort to determine the nature of this indication, another exposure was made at a 45 degree angle to the weld. Figure No. 28 is a photograph of the X-ray film. The two-inch long indication was apparently the combined effect of many individual spots of porosity.

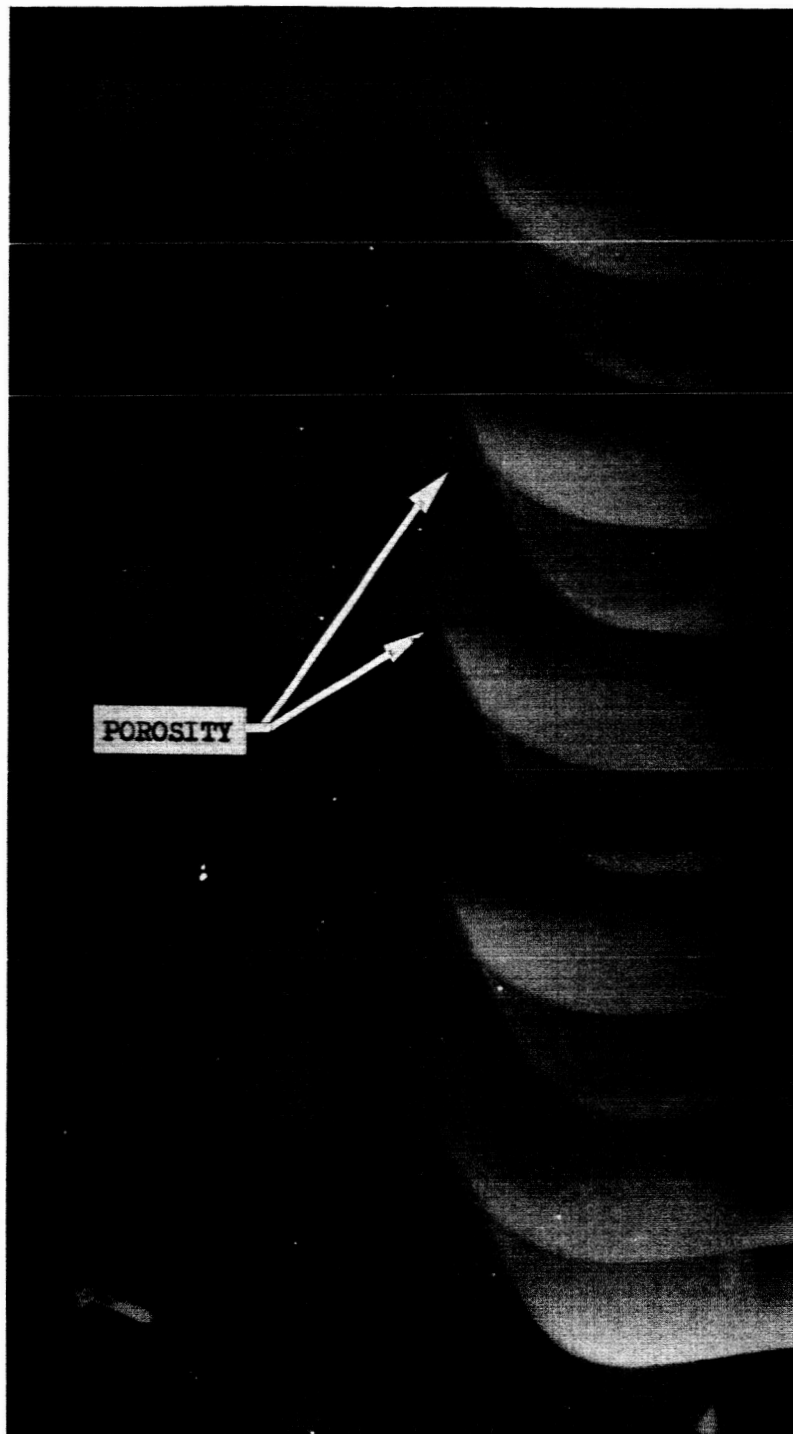
Figure 29

Photograph of the X-ray Film Showing the Porosity Condition
Existing in the Shroud-to-Blade Weld of the Second-Stage Dummy

Figure No. 29 is a photograph of the X-ray film taken of the outer shroud weld in the second dummy welded and brazed showing the fewer isolated areas of porosity that existed. This improvement in the porosity condition as noted in Figure No. 28 has been attributed to the carbide burr polishing of the blade to remove all effects of glass bead blast.

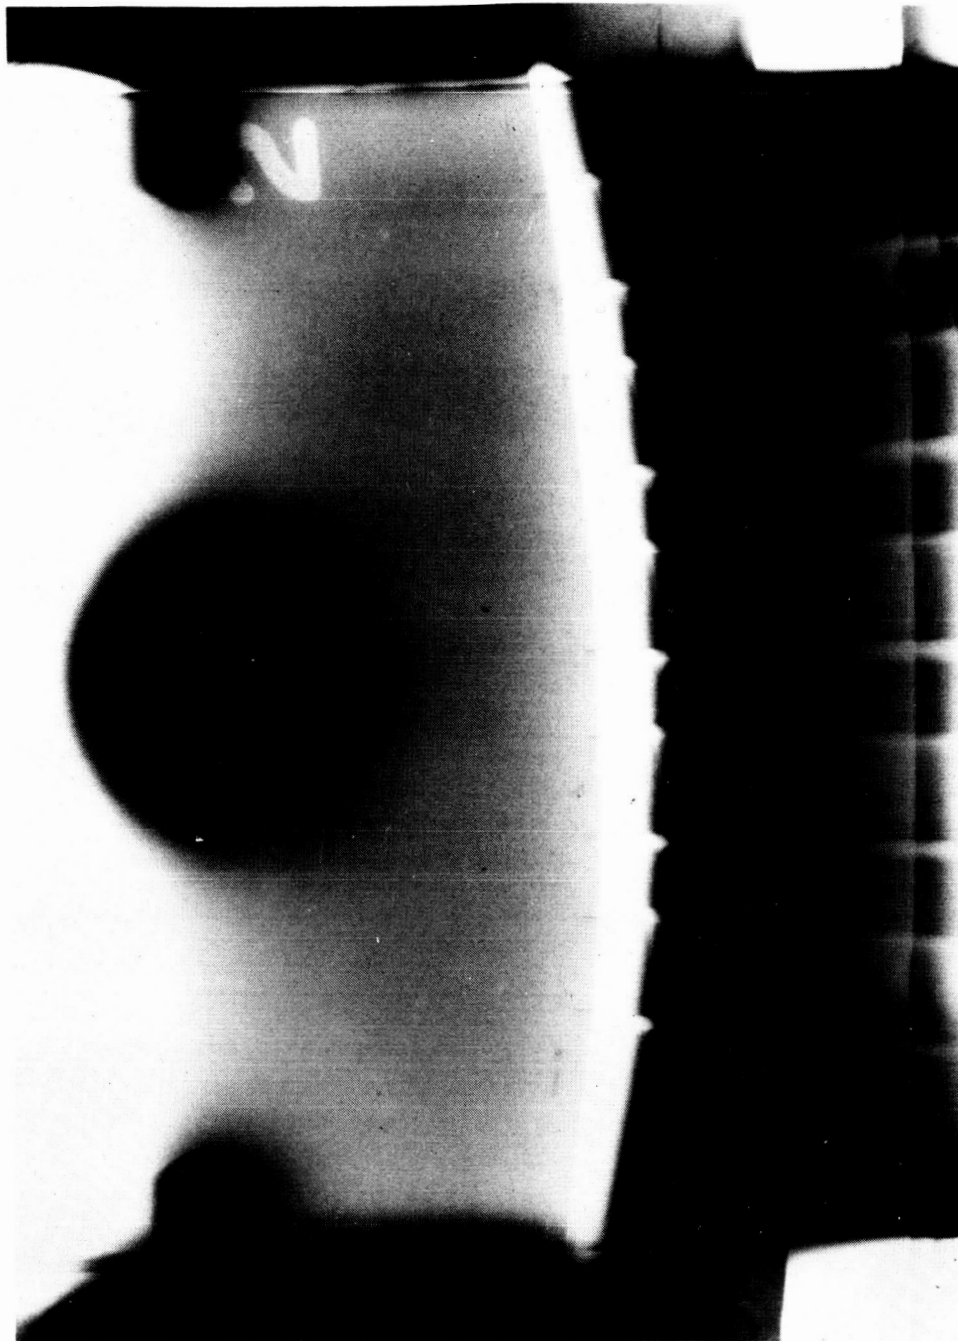
Figure 30

Photograph of the X-ray Film Showing the Electron-Beam Weld
Area of the Blade-to-Center-Hub Joint

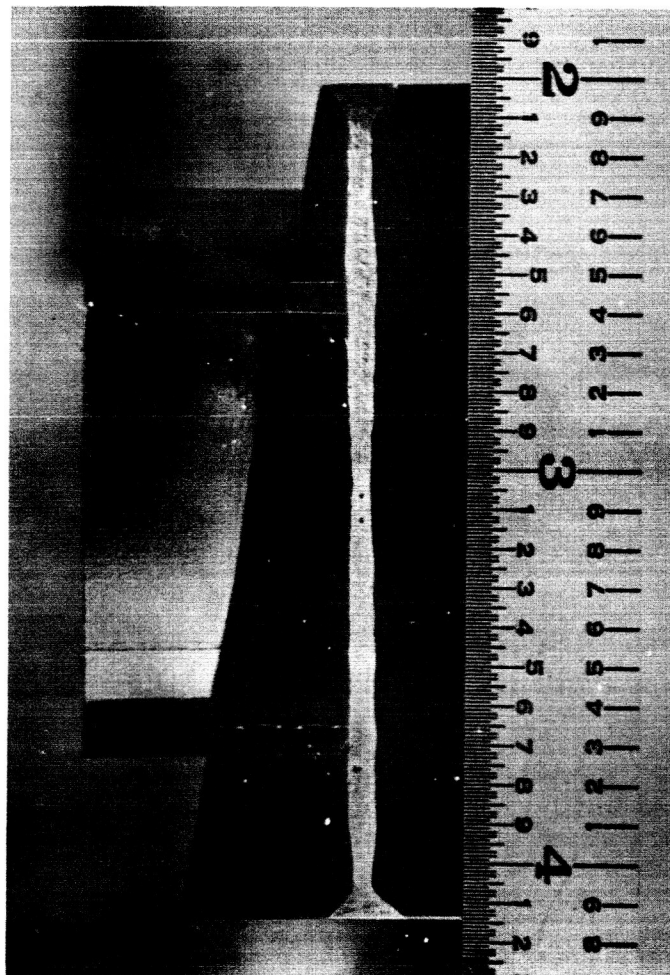
Figure 31

Photomicrograph of Electron-Beam Weld in the Hub Section of the Dummy Rotor

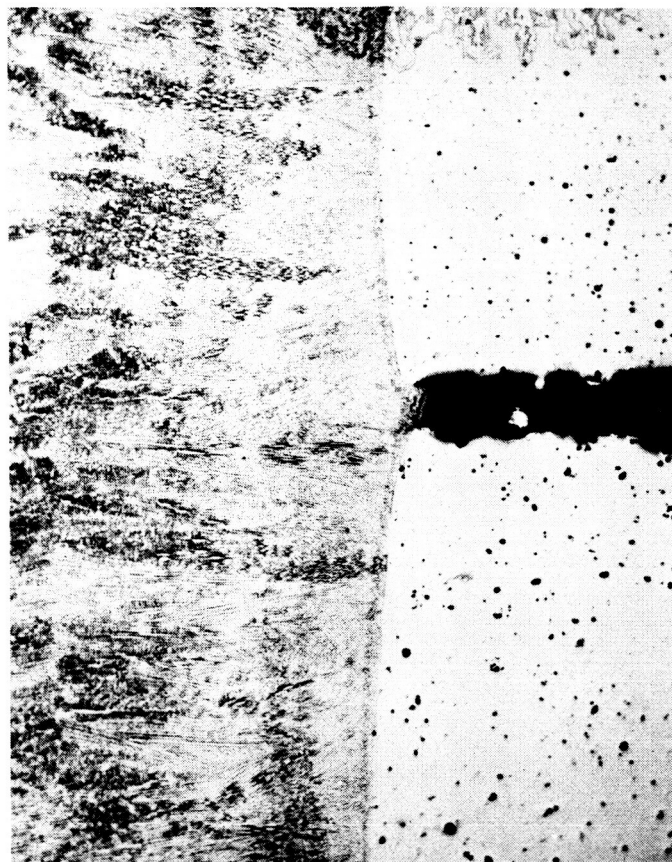
Figure 32

Photomicrograph of Electron-Beam Weld Joint at the Junction of the Blade and Hub

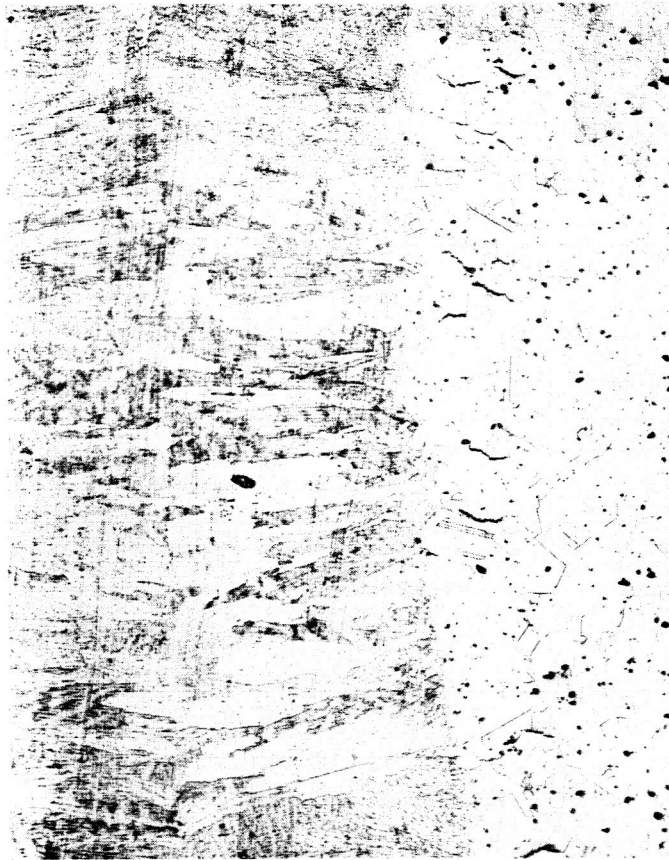
Figure 33

Photomicrograph of the Electron-Beam Weld in the Hub Section
of the Dummy Rotor Showing the Microfissuring Condition
Immediately Below the Nail Head

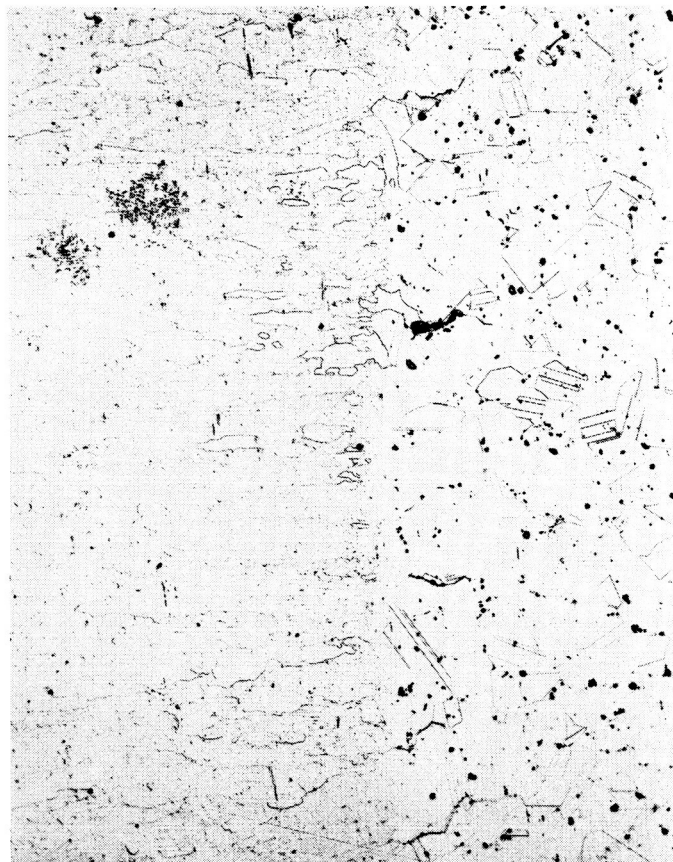
Figure 34

Photomicrograph of the Electron-Beam Weld in the Outer Shroud
Section After Brazing, Aging, and Finish Machining

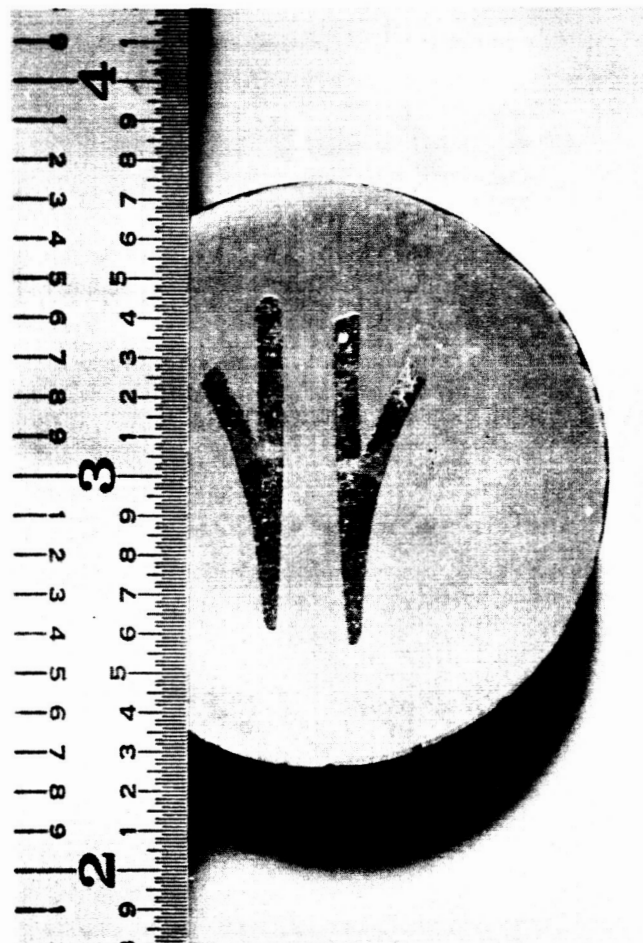
Figure 35

Photomicrograph of the Electron-Beam Weld Joining the Blade
to the Trailing Edge Extension

Figure No. 35 is a photograph of the blade-to-extension weld. Only one small fissure near the nail head of the electron beam weld, approximately 0.005-in. in length, could be detected. ~~Other than this one fissure, the weld appeared to be sound and have good penetration as well as fusion characteristics.~~

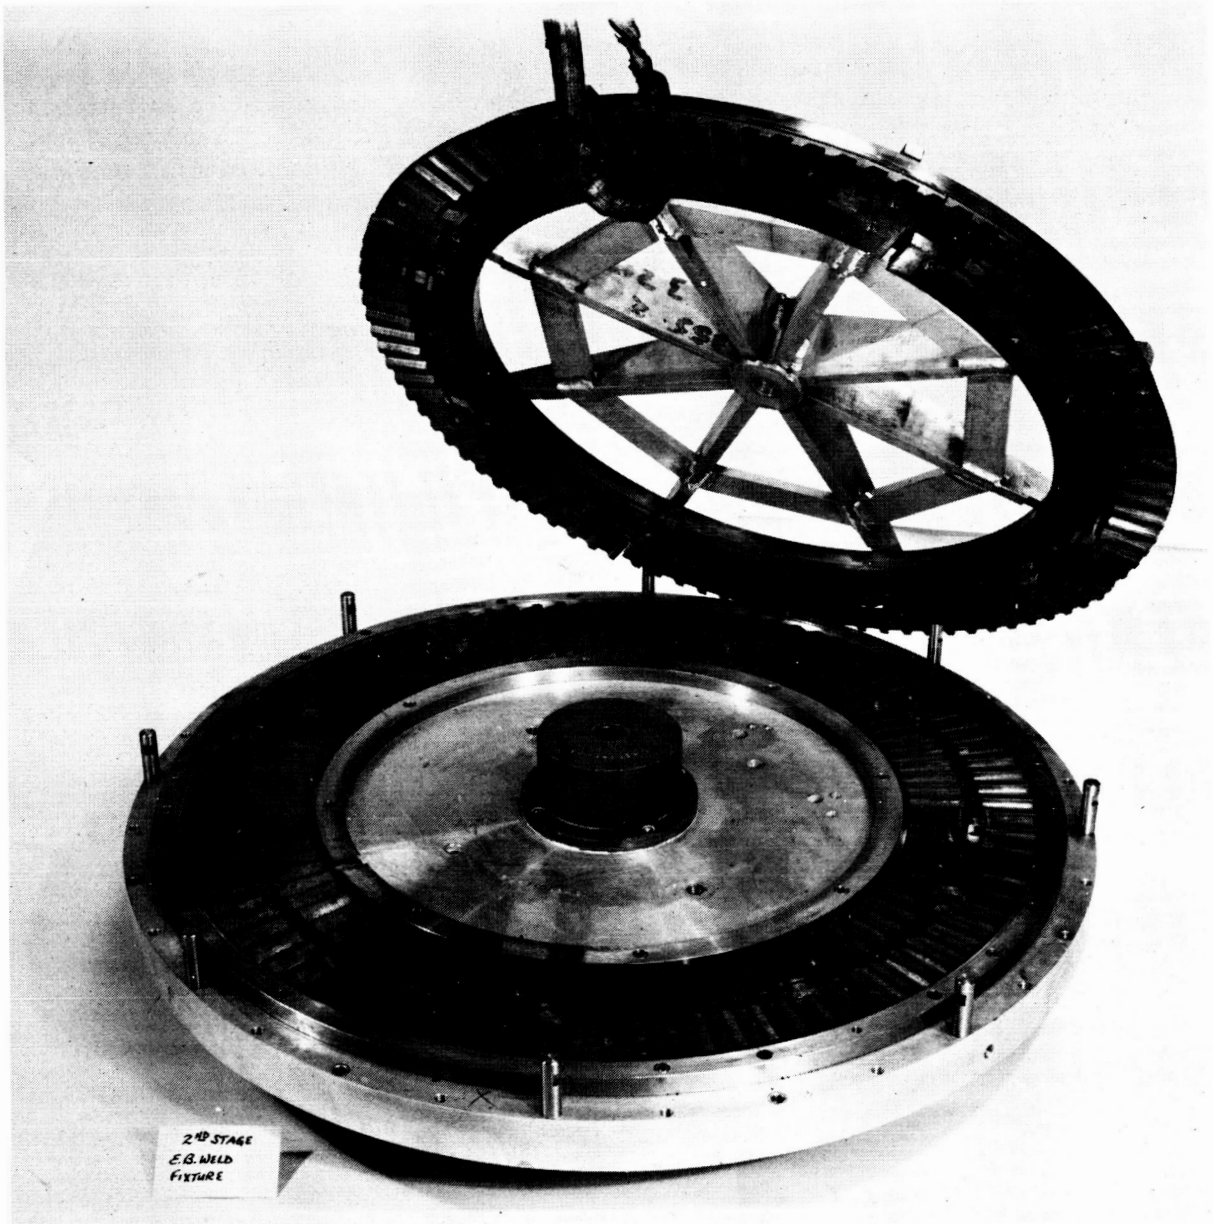
Figure 37

Electron-Beam Weld Fixture for Second-Stage Rotor

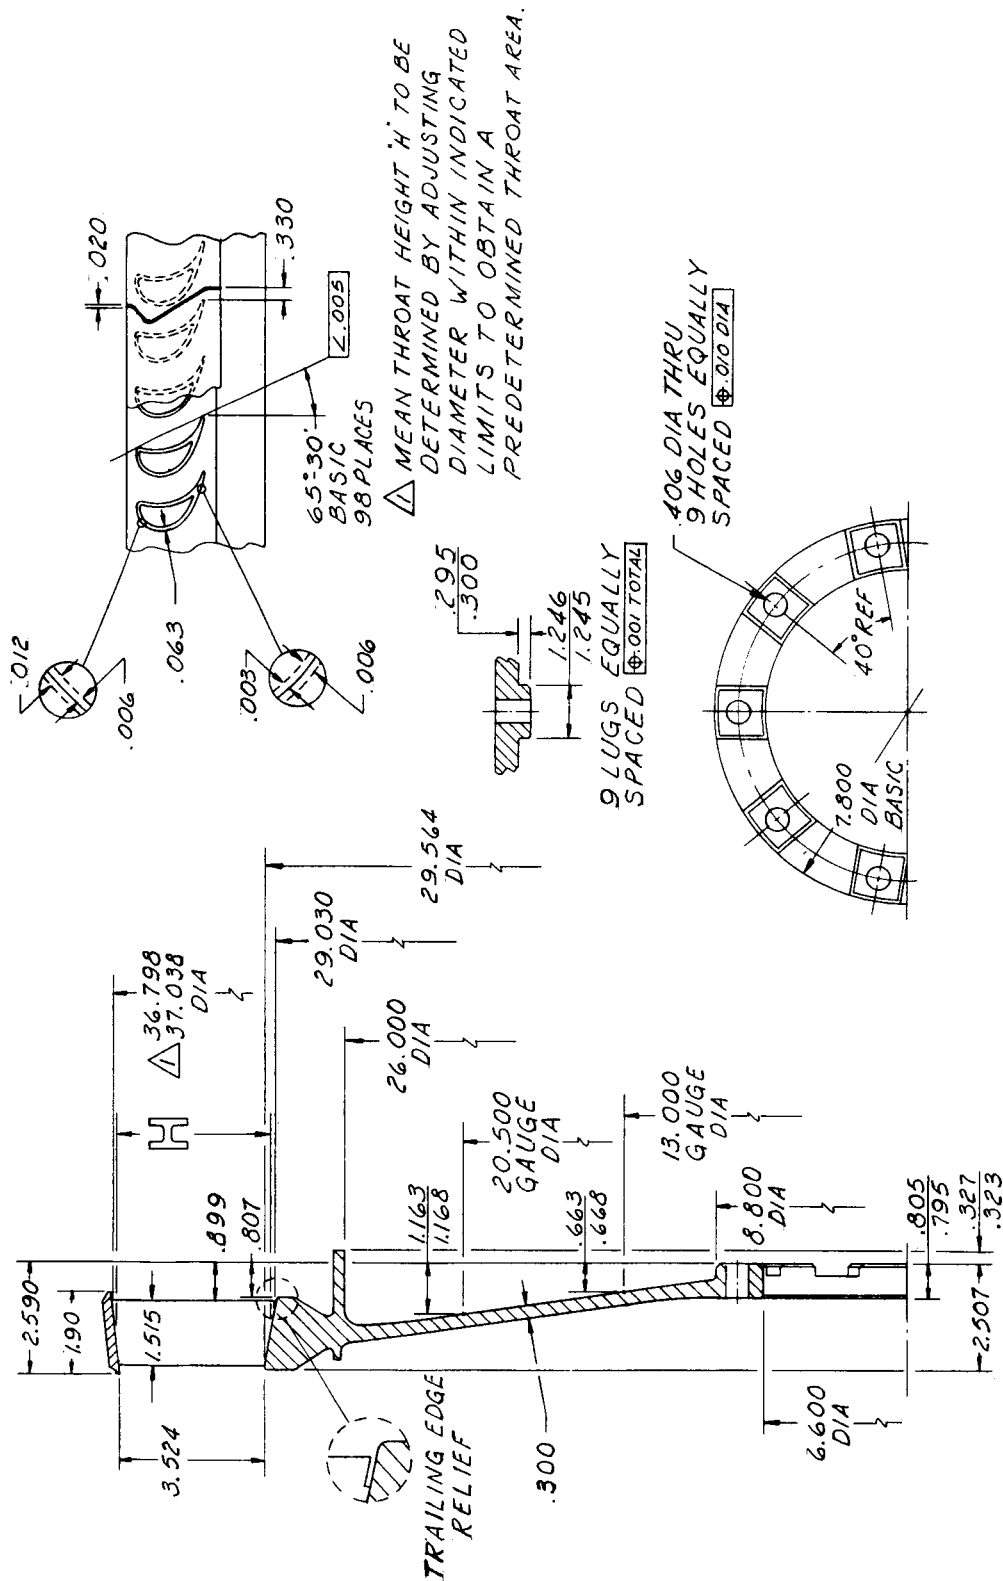
Figure 38

Rotor Assembly - Stage 1

Figures No. 38 and No. 39 show the major characteristics of the two rotors in the final machined condition.

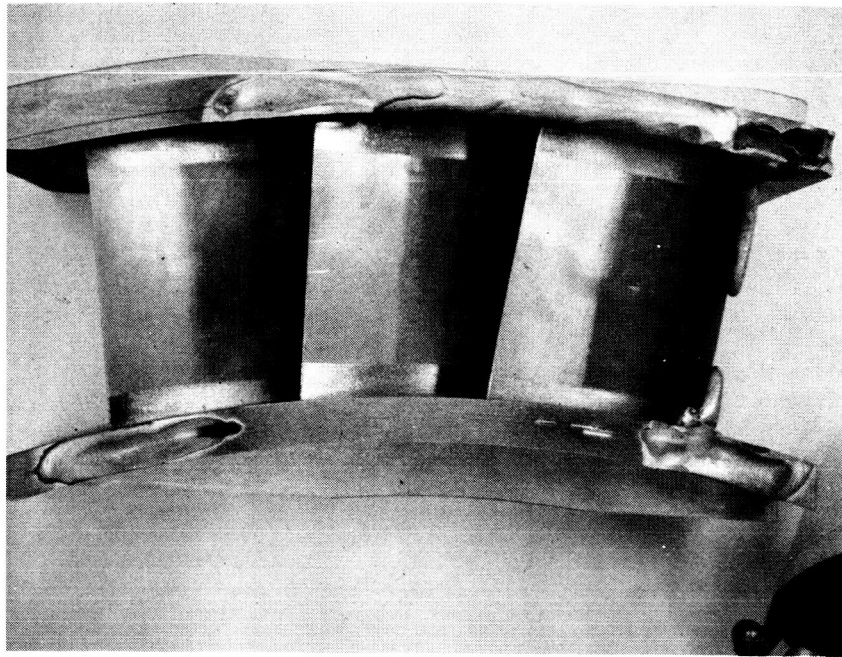
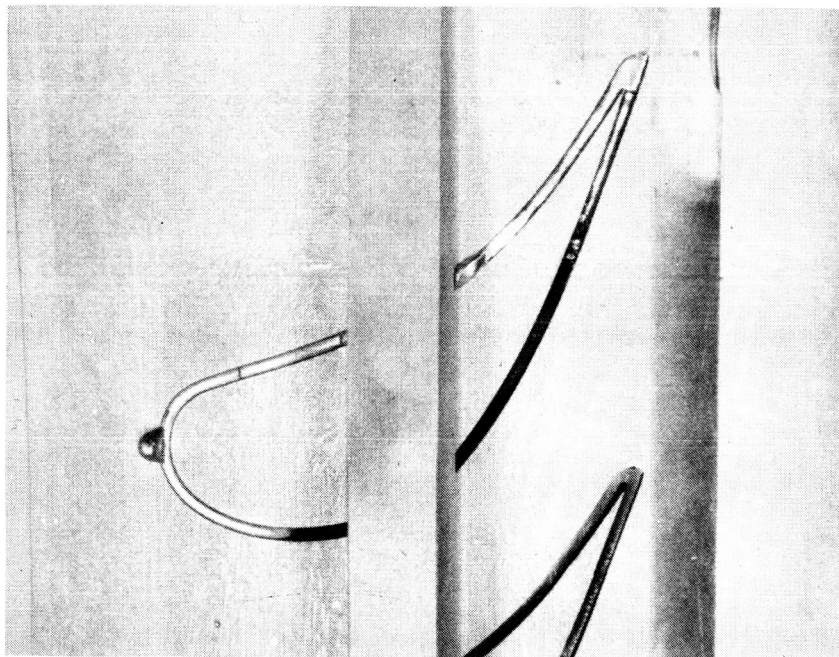
Figure 40

Excessive Melting on Nozzle Weld Samples

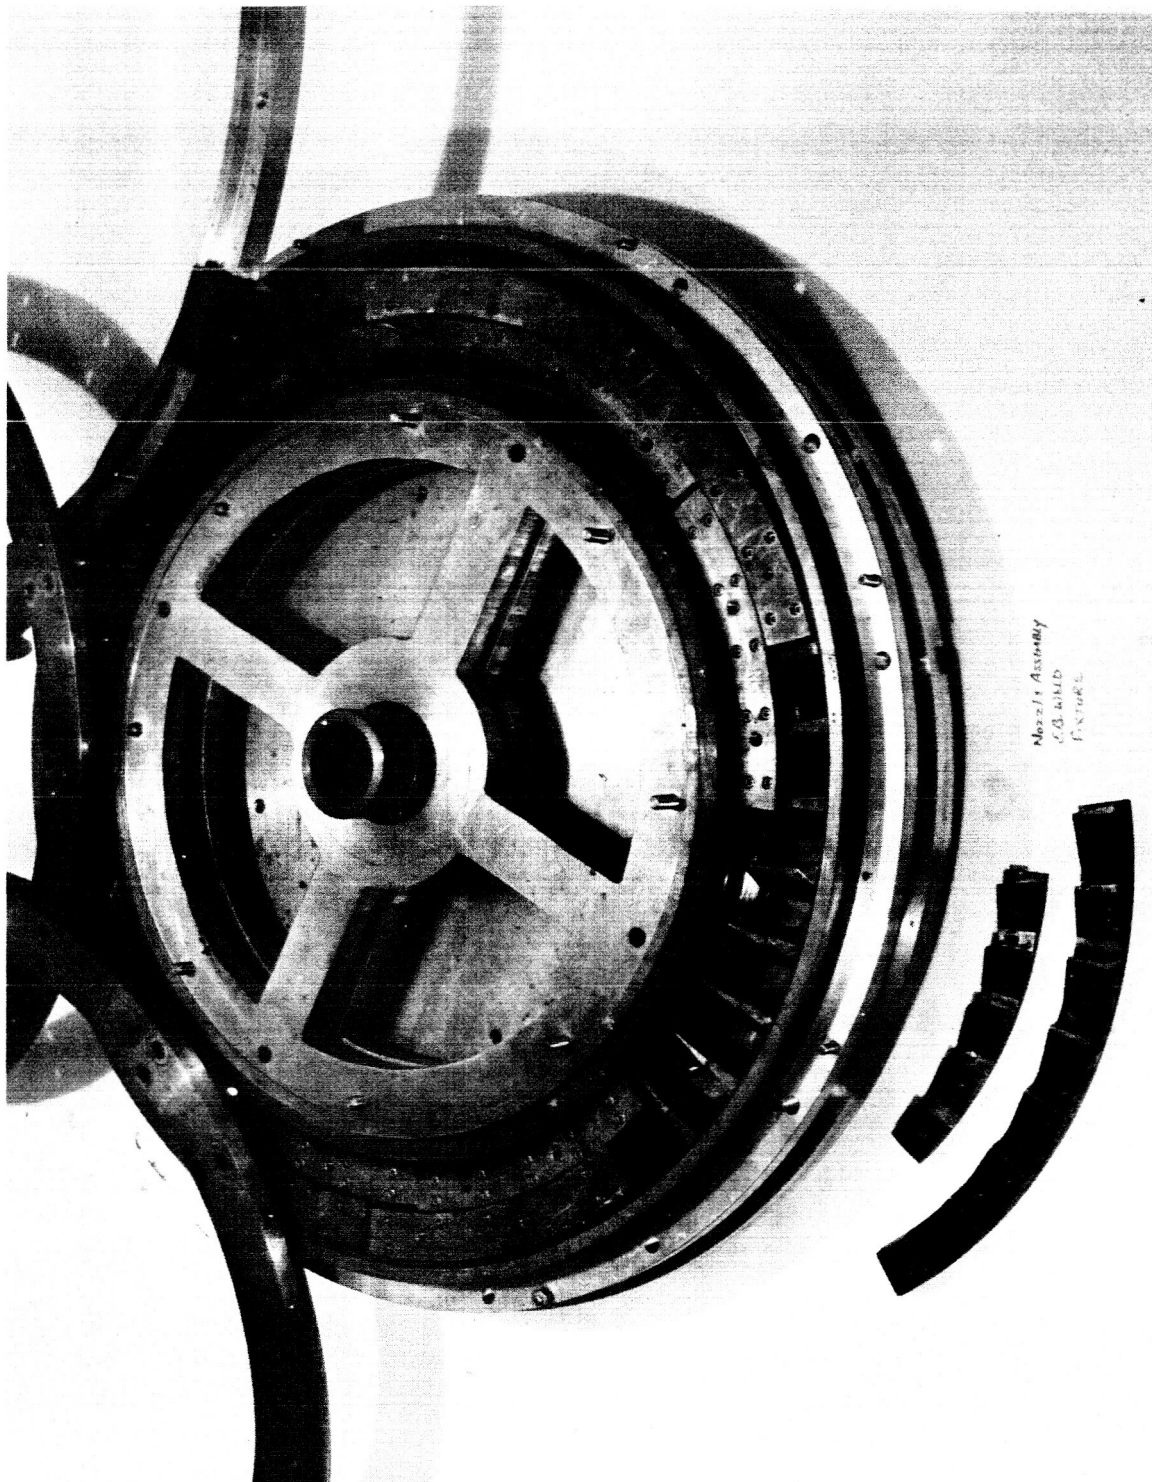
Figure 41

Electron-Beam Weld Fixture for Nozzle

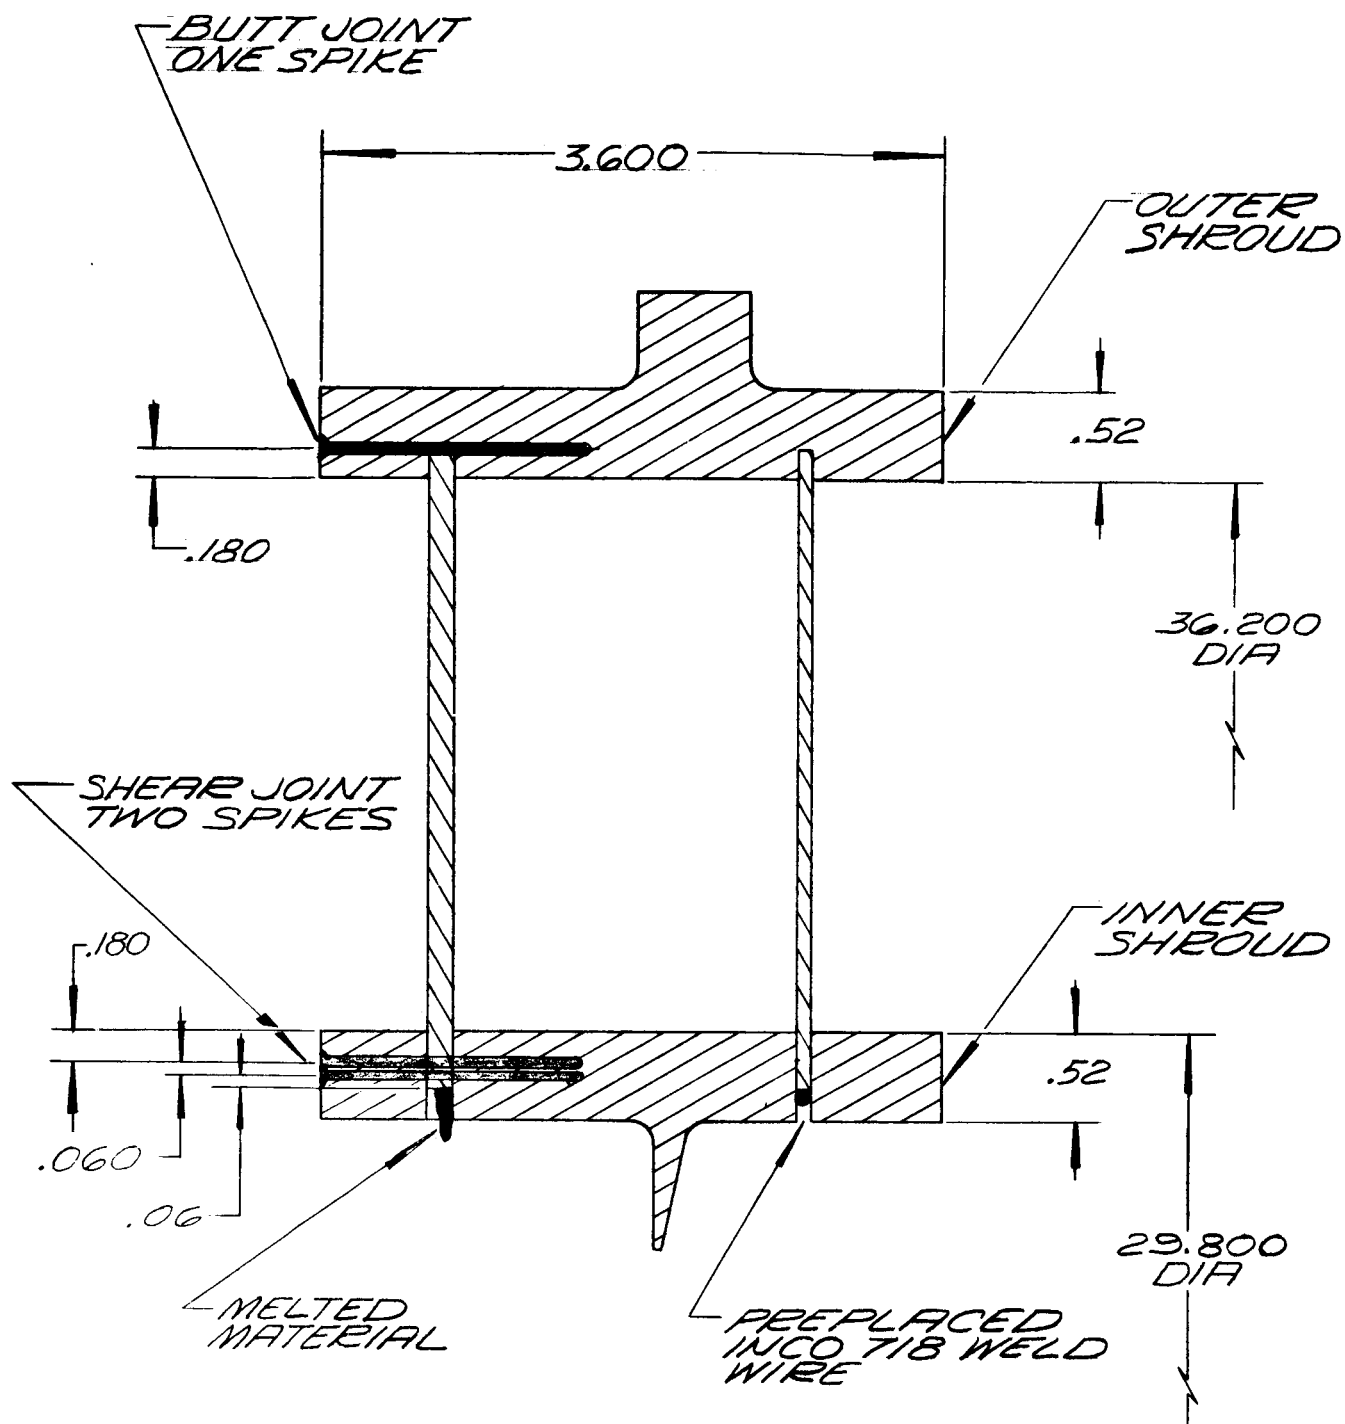
Figure 42

Nozzle Electron-Beam Weld Spike Positions

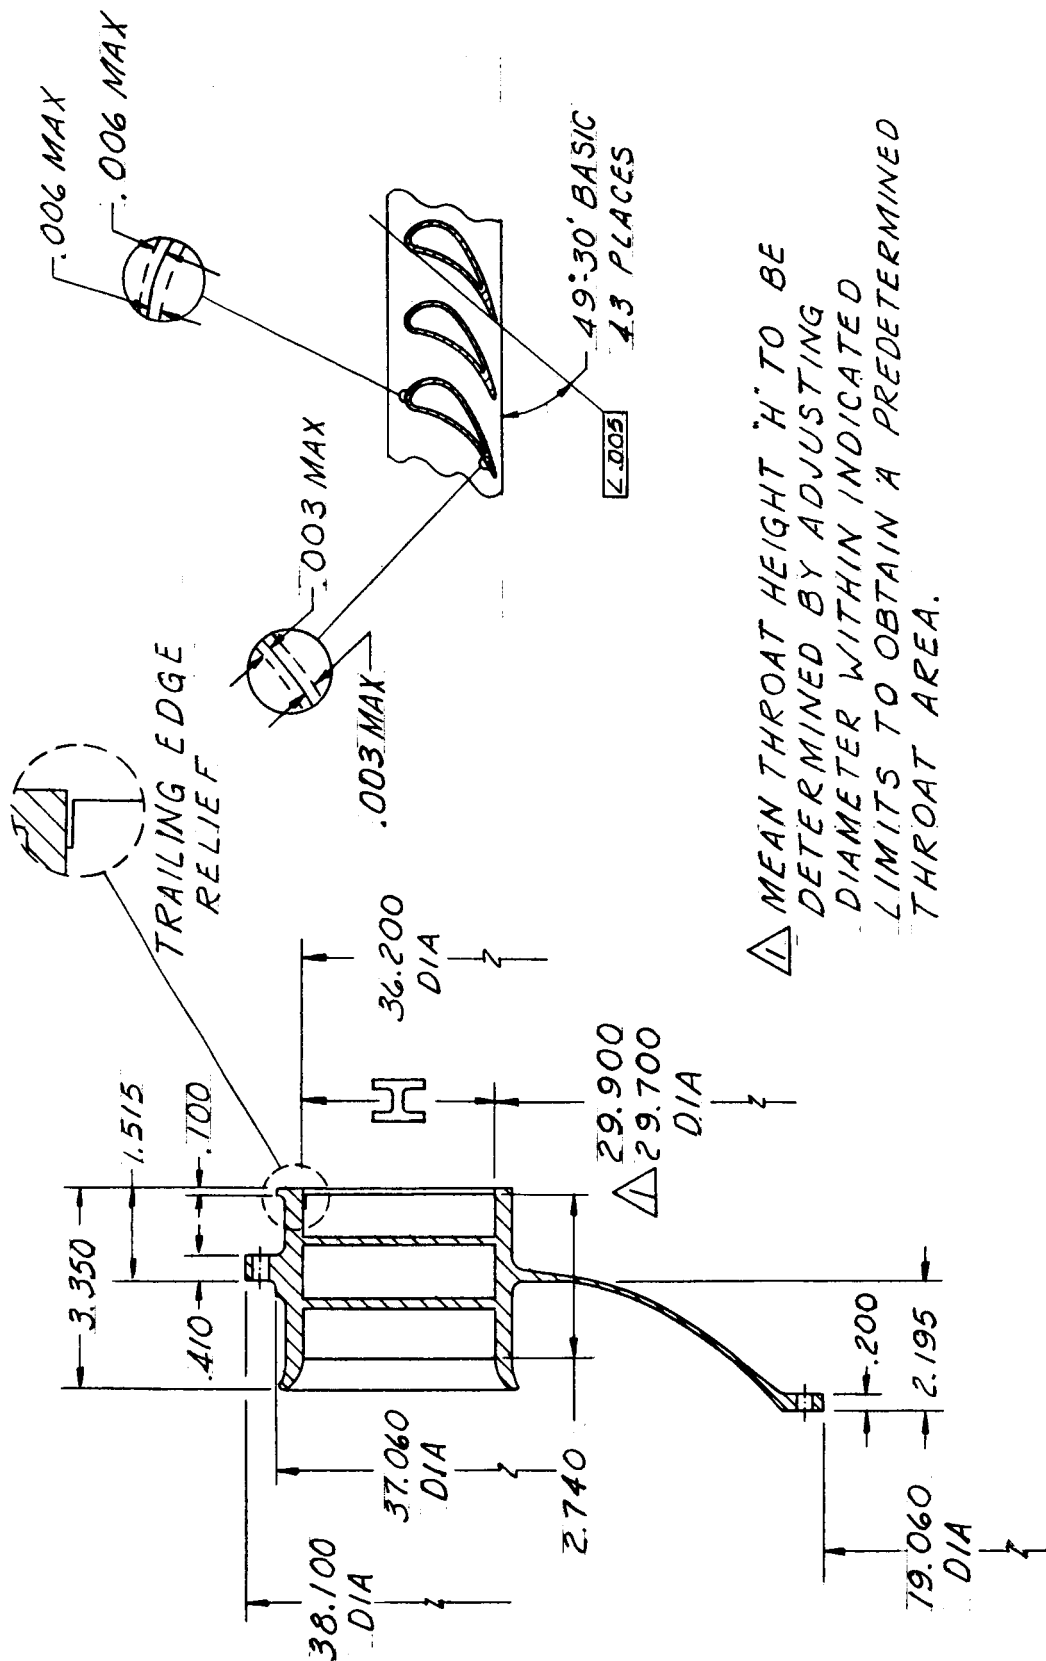
Figure 43

Nozzle Assembly
